# BG Quality Products

## Long Lasting Detonation Sensor Harness for Caterpillar G3520C Engine

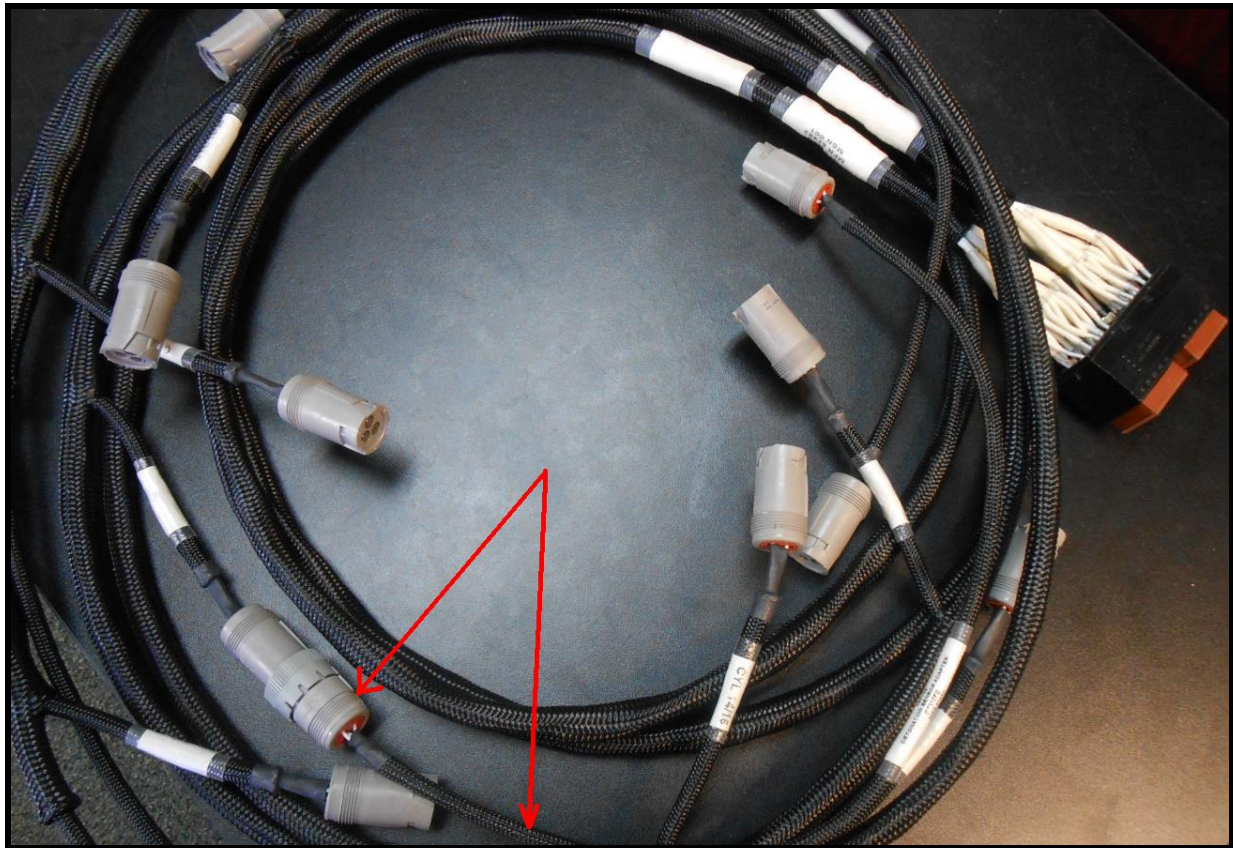
Harness shown with one jumper – see arrows  
The harness is shipped with ten jumpers (one jumper serves two cylinders)

This new detonation harness is a vast improvement over the OEM design. The OEM harness is located behind the exhaust manifold where it is exposed to heat and damage from exhaust leaks. This aftermarket harness is routed along the main engine rail and incorporates replaceable jumpers up to the sensors. If there is a leak that damages the harness jumper, simply remove the jumper by hand and install a new one. Within minutes, you are back online with little downtime or expense.
